## **“IT’S NOT EASY BEING GREEN”: THE AUDUBON HOUSE**

**Caroline Cassavoy Michelle Drollette, Jason Franzen, Pablo Garcia, Carlin MacDougall, Shiva Mandell, Aleks Mergold, Vladimir Pajkic, Sneha Patel, Nick Rajkovich, John Tsai**

## “It’s Not Easy Being Green”: The Audubon House

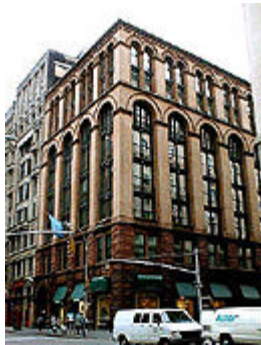
Fig. 1. National Audubon Headquarters Building, 700 Broadway St, NYC

The National Audubon Society, an organization dedicated to the preservation of the environment, maintains its lower Manhattan headquarters in the eight-story Schermerhorn building designed in 1891 by George W. Post. Audubon and the Croxton Collaborative renovated the building with the intent of creating an example of energy efficient and environmentally responsible architecture, while remaining an economically viable proposition for the National Audubon Society. Thus, the Audubon Society was able to preserve valuable resources and a historic landmark.

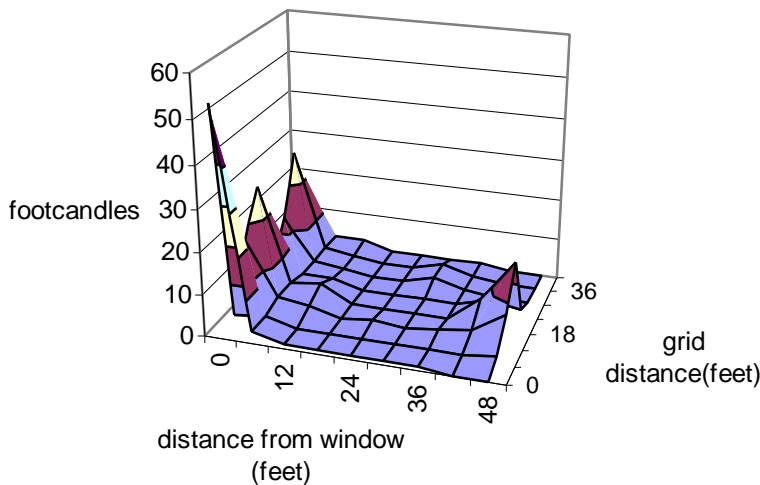
Fig. 11. Daylight contours from perimeter zone

Our measurements during an unoccupied day where we could turn off all of the electric lighting revealed that daylight penetration was minimal. For example, light levels dropped from 54 foot-candles at the window to three foot-candles just six feet from the window. We could see from the isolux drawing (Fig. 12), that the geometry of the office furnishings appeared to hinder the penetration of daylight from the window, but only by approximately two feet.

During this time of year (winter) when we took these measurements, we expected the lower winter sun angles to maximize the penetration of daylight. However, the combination of window geometry on the 6<sup>th</sup> floor and the surrounding buildings, prevented maximum daylight penetration. On the other hand, the occupants overwhelmingly agreed that daylight enhanced their workplace (discussed in later) demonstrating that while the light readings were low in the interior zone, daylight and the visual connection to the daylight through the windows over the office partitions has a positive psychological impact.

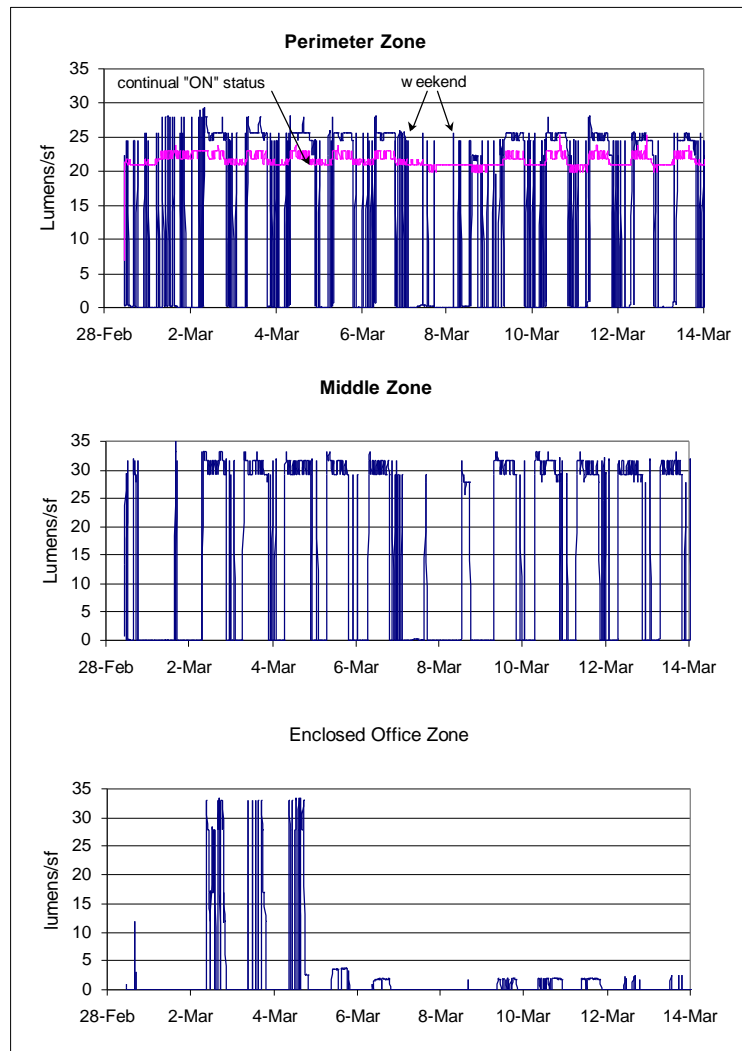
In our quest to find the savings by dimming, we found many surprises. From the “hobo slings” placed at the perimeter window zone (where we knew dimming should occur), we found lighting circuits that worked with the occupancy sensors and also circuits that remained on constantly during non-office hours. Most significantly, we found that none of the lighting circuits in the perimeter zone of the 6<sup>th</sup> floor actually dimmed, leading us to wonder if the only-installed daylight sensor was calibrated.

The perimeter zone graph (Fig. 21) shows two sets of readings, one circuit which appears to be connected to an occupancy sensor, where patterns of weekly and weekend use are evident and the other circuit constantly “ON” through the weekends.

Figure 21. Lighting use pattern for perimeter, interior and enclosed office spaces. Note the weekly use pattern of lights. More significantly, note that there is no “decay” of ambient light which would indicate dimming occurred.

4. One daylight sensor located in the perimeter zone does not adequately control the variable lighting conditions as the sun moves from the eastern to the western portions of the floor plan. It seems that installation of at least two more daylight sensors in this zone would allow the electric lighting respond to the lighting conditions of the entire floor.

7. Non-functional occupancy and daylight sensors, significantly reduced performance of the integrated lighting system in terms of energy savings (potentially \$5000/year).

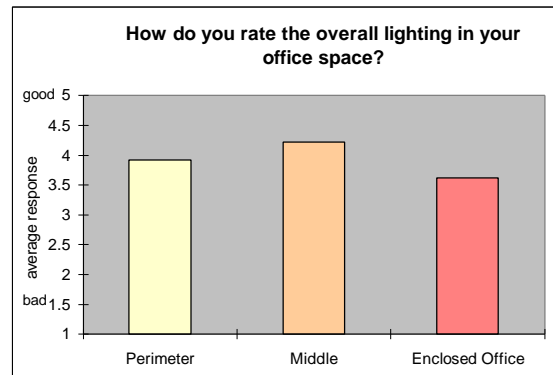
Fig. 24. Response to overall lighting

Of 150 workers, 66 (44%) returned completed surveys. On a scale of 1 to 5 (5 = outstanding), the Audubon workers rated the *overall lighting* in the office at an average of 4, regardless of whether they were seated near the window or toward the interior of the space (Fig. 24). However, Audubon workers sitting along the perimeter window zone rated the *quality of daylight* at their workspaces more favorably than those seated in the middle or enclosed zones (Fig. 25). On other qualities of light such as *color* and *enhancement of daylight to the workspace*, office workers responded with better than average ratings, regardless of seating location. (see Appendix D for additional analysis).

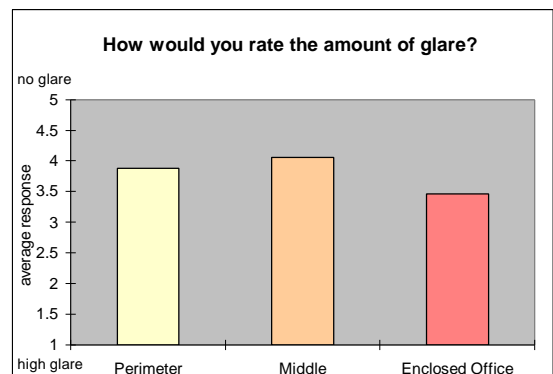
Fig. 26. Response to glare

It's also interesting to note that despite glare conditions found along the perimeter zone, that people rated both the overall lighting and the quality of light in the workspace favorably.
