Northeast Central Campus Diagnosis
 December 1999
Summary
Areas that Work Well & Need Fixing

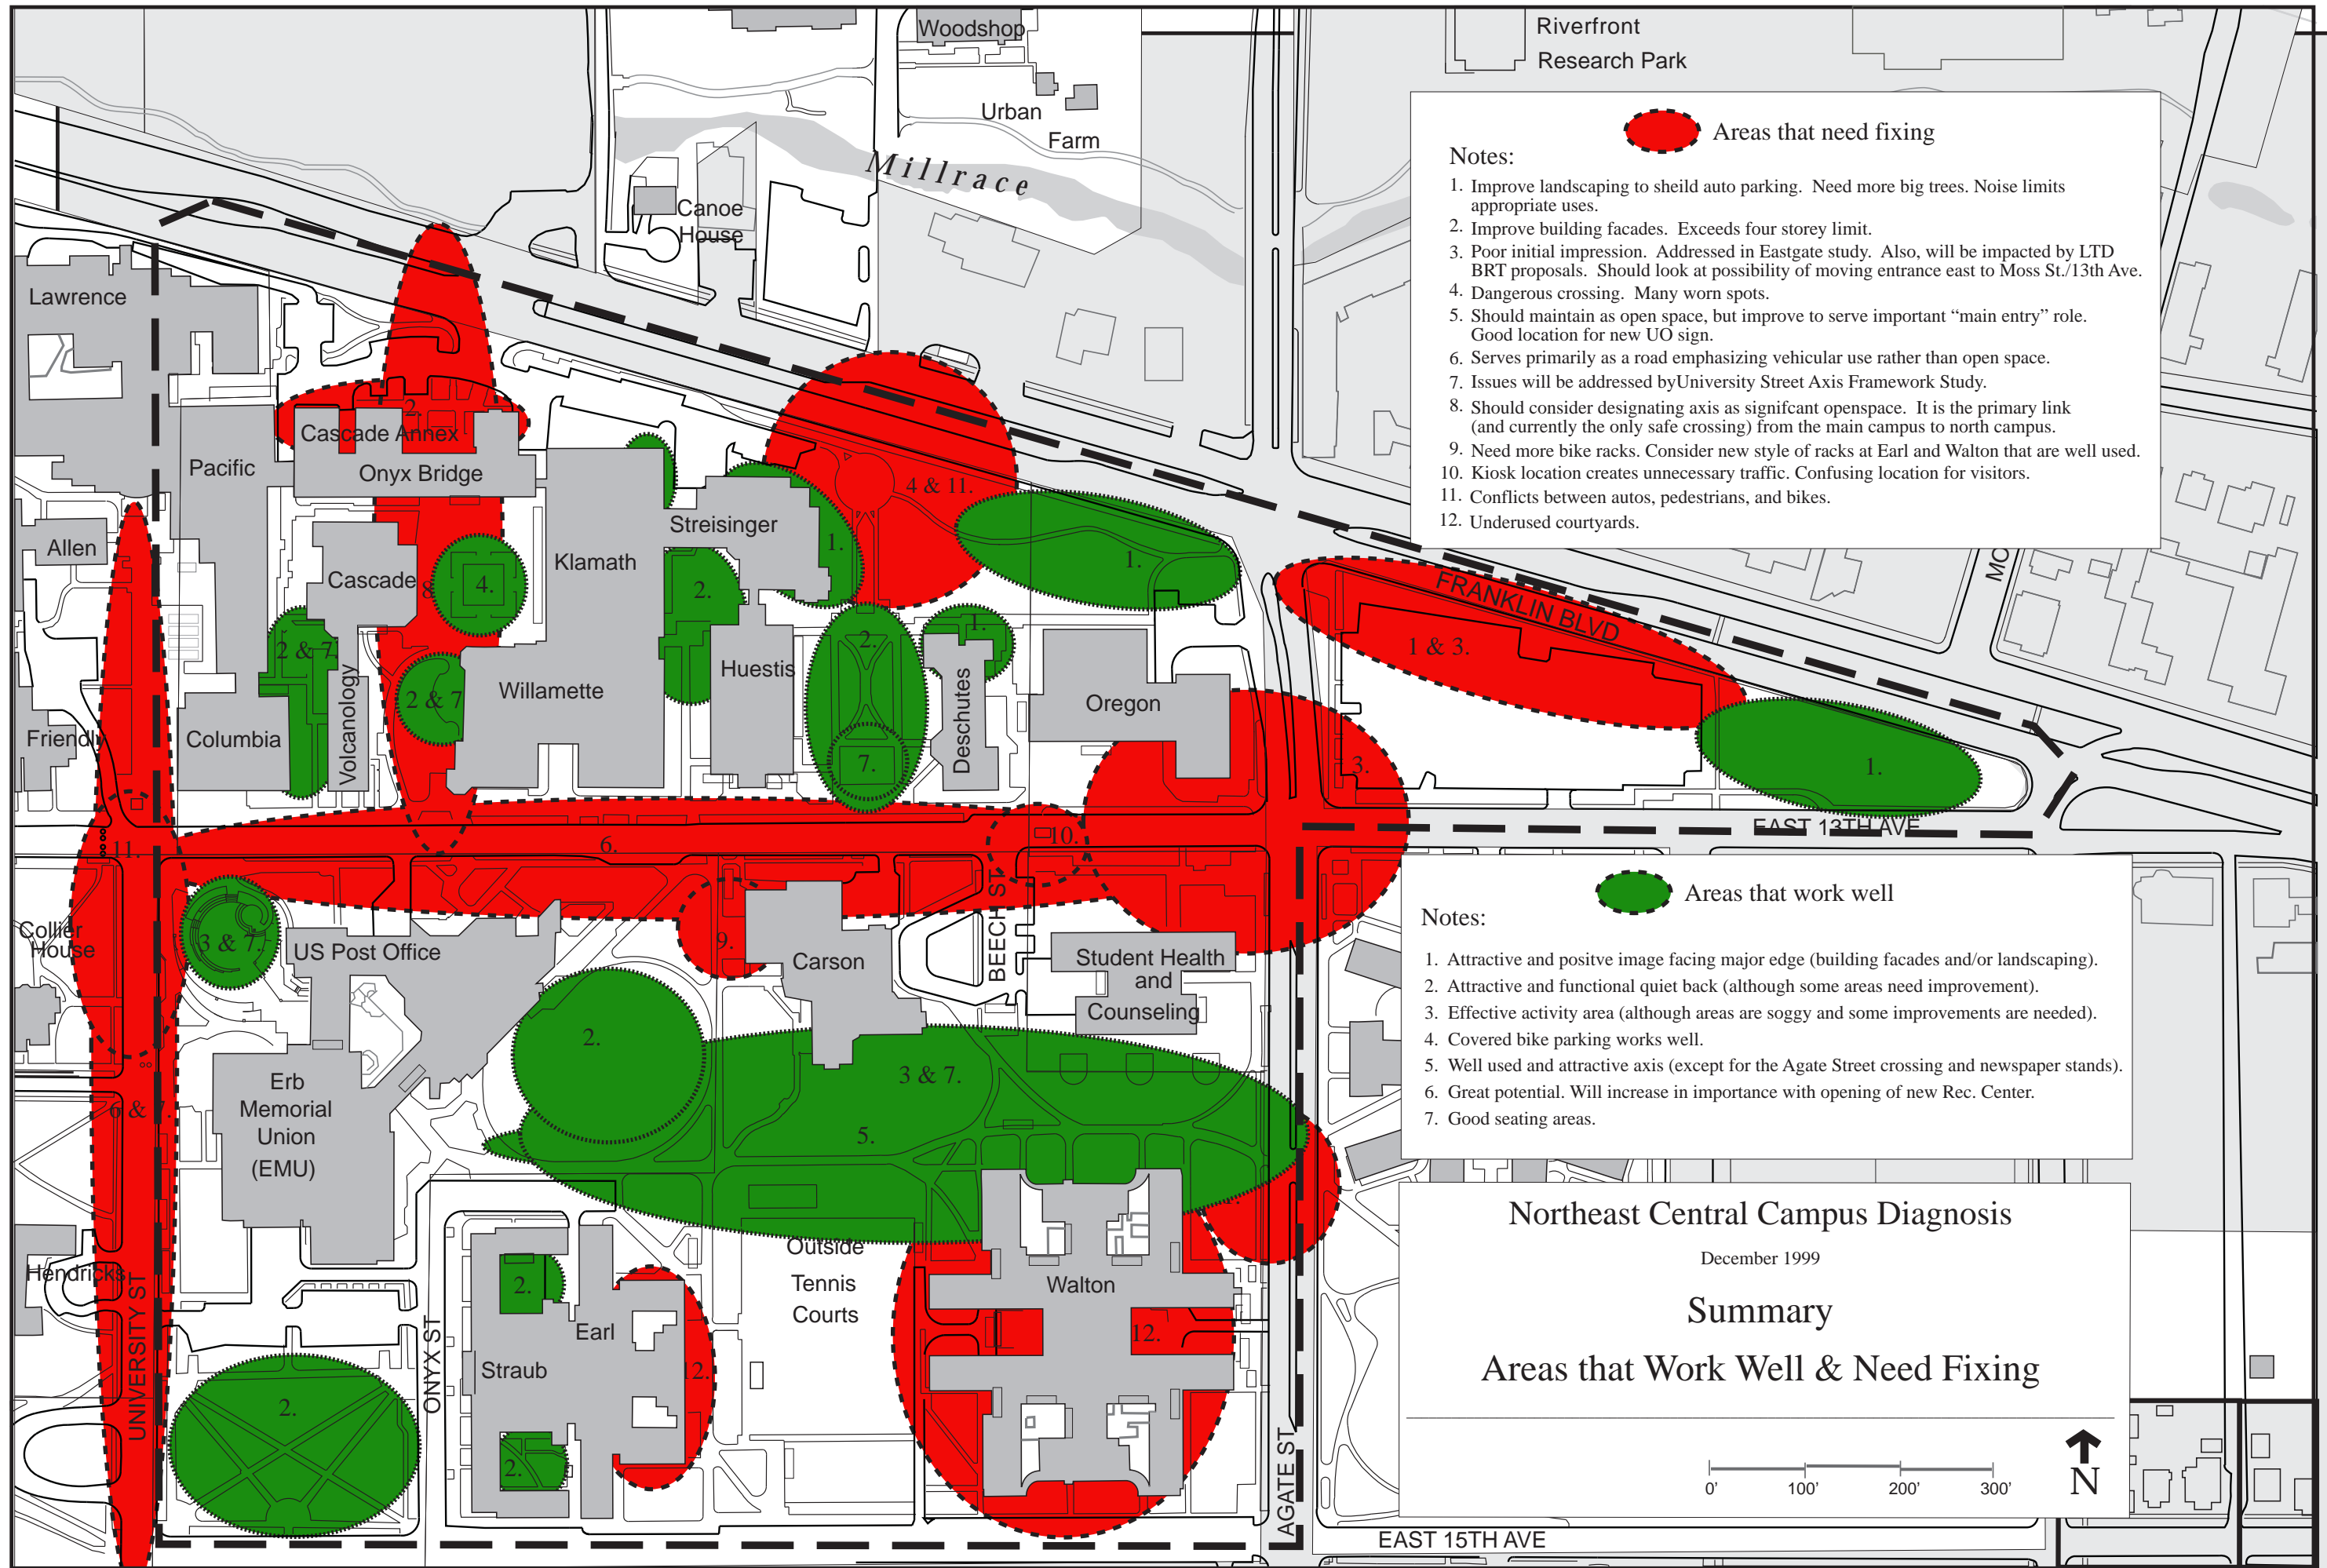
- 1. Improve landscaping to shield auto parking. Need more big trees. Noise limits appropriate uses.
- 2. Improve building facades. Exceeds four storey limit.

- 3. Poor initial impression. Addressed in Eastgate study. Also, will be impacted by LTD BRT proposals. Should look at possibility of moving entrance east to Moss St./13th Ave.

- 4. Dangerous crossing. Many worn spots.
- 5. Should maintain as open space, but improve to serve important "main entry" role. Good location for new UO sign.

- 6. Serves primarily as a road emphasizing vehicular use rather than open space.
- 7. Issues will be addressed by University Street Axis Framework Study.

- 8. Should consider designating axis as significant openspace. It is the primary link (and currently the only safe crossing) from the main campus to north campus.

- 9. Need more bike racks. Consider new style of racks at Earl and Walton that are well used.
- 10. Kiosk location creates unnecessary traffic. Confusing location for visitors.

- 11. Conflicts between autos, pedestrians, and bikes.
- 12. Underused courtyards.

- 1. Attractive and positive image facing major edge (building facades and/or landscaping).
- 2. Attractive and functional quiet back (although some areas need improvement).
- 3. Effective activity area (although areas are soggy and some improvements are needed).
- 4. Covered bike parking works well.
- 5. Well used and attractive axis (except for the Agate Street crossing and newspaper stands).
- 6. Great potential. Will increase in importance with opening of new Rec. Center.
- 7. Good seating areas.
