Summary: Areas that Work Well & Areas that Need Fixing

South
Central
Campus
Diagnosis
2002

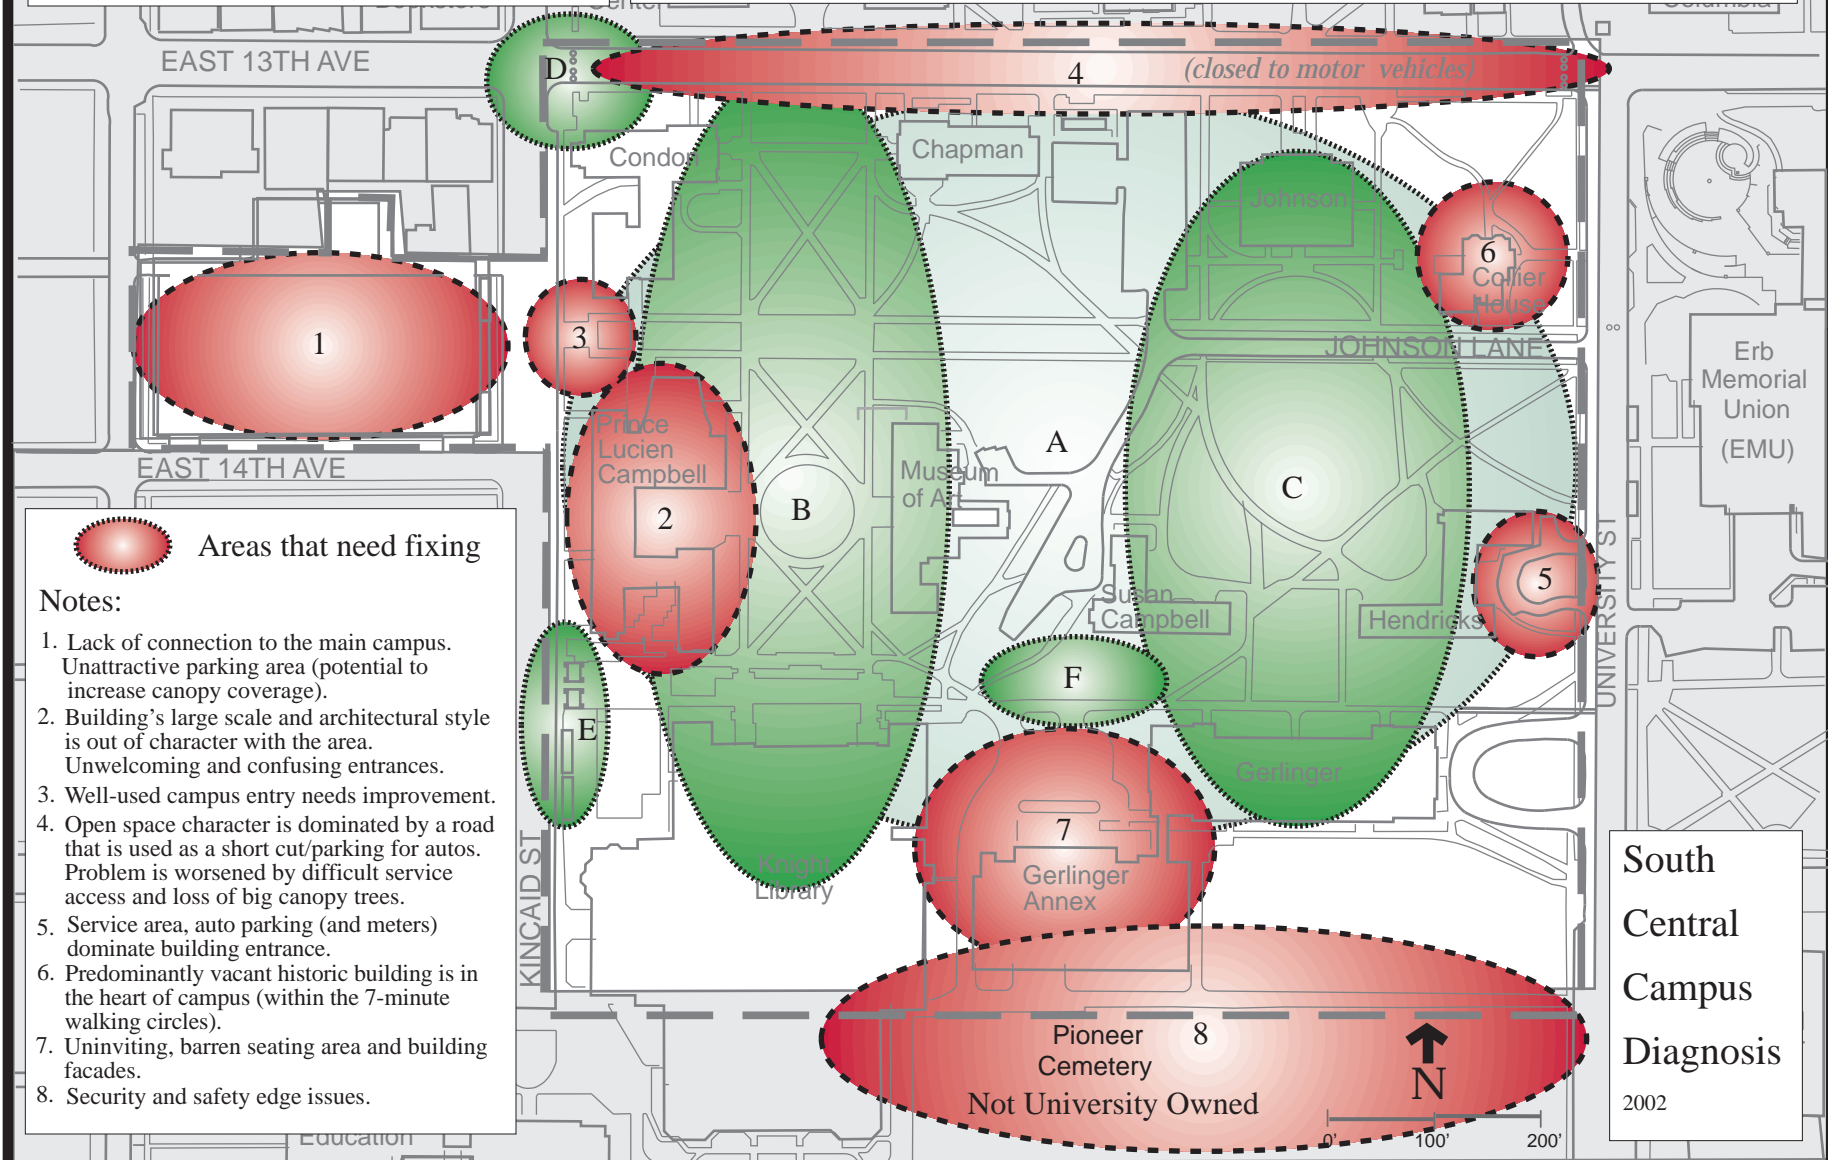
- A. Pedestrian pathway network is very effective.
- B. Open space is well defined by the landscape features, mature trees and historic buildings.
- C. Open space (with mature trees and historic landscape features) and associated historic buildings are very attractive. Appealing pedestrian scale.
- D. 13th Avenue gateway is welcoming and creates a cohesive campus design. Integrated seating ledges are well used.
- E. Knight Library west gate creates an attractive entrance and provides much-needed covered bike parking.
- F. Mature tree canopy creates an attractive walkway.

- 1. Lack of connection to the main campus. Unattractive parking area (potential to increase canopy coverage).
- 2. Building's large scale and architectural style is out of character with the area. Unwelcoming and confusing entrances.
- 3. Well-used campus entry needs improvement.
- 4. Open space character is dominated by a road that is used as a short cut/parking for autos. Problem is worsened by difficult service access and loss of big canopy trees.
- 5. Service area, auto parking (and meters) dominate building entrance.
- 6. Predominantly vacant historic building is in the heart of campus (within the 7-minute walking circles).
- 7. Uninviting, barren seating area and building facades.
- 8. Security and safety edge issues.
