**LANDSCAPE RESOURCE SURVEY**  
 University of Oregon Campus Heritage Landscape Plan  
 Eugene, Lane County, Oregon • Spring 2007

**Gerlinger Entrance Green (w)**

Landscape Resource Survey  
**GERLINGER ENTRANCE GREEN**

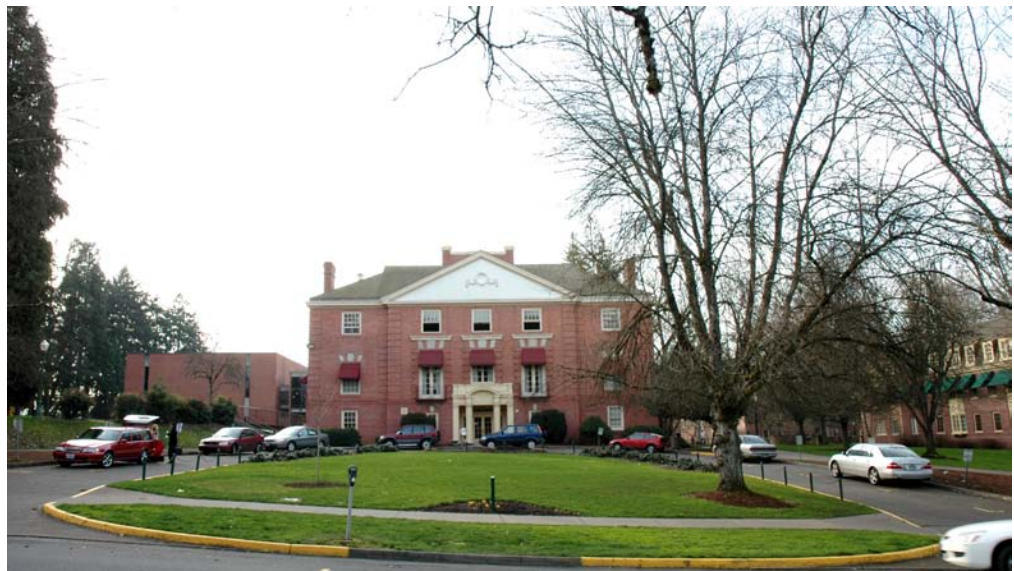
View looking west at Gerlinger Hall.

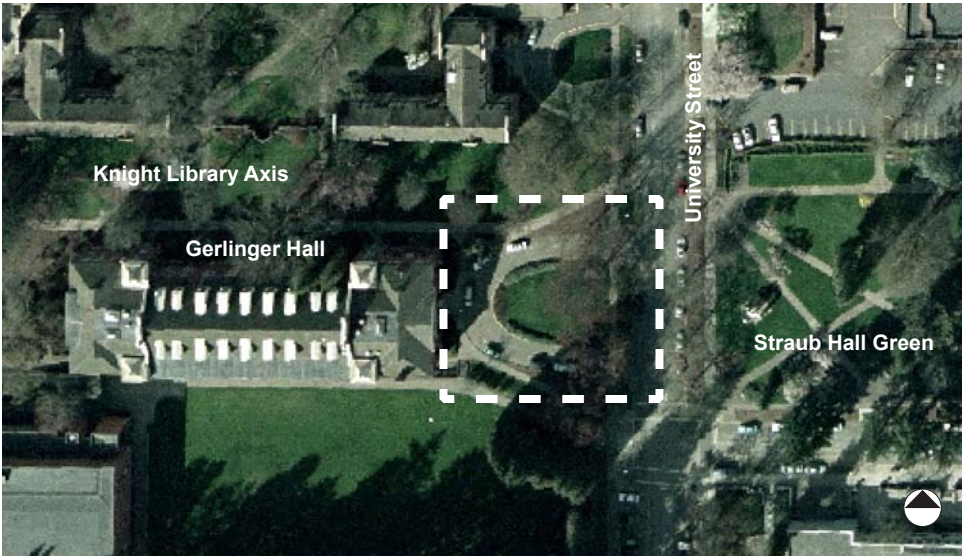
*2004 aerial of the Gerlinger Entrance Green*

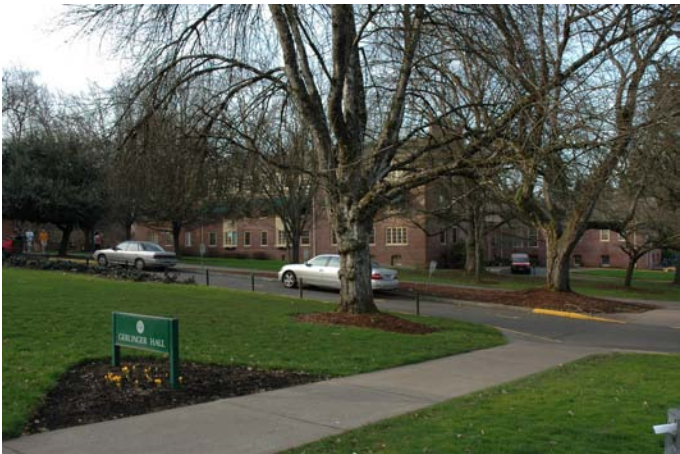
*Northwest view across the Green and towards Hendricks Hall.*

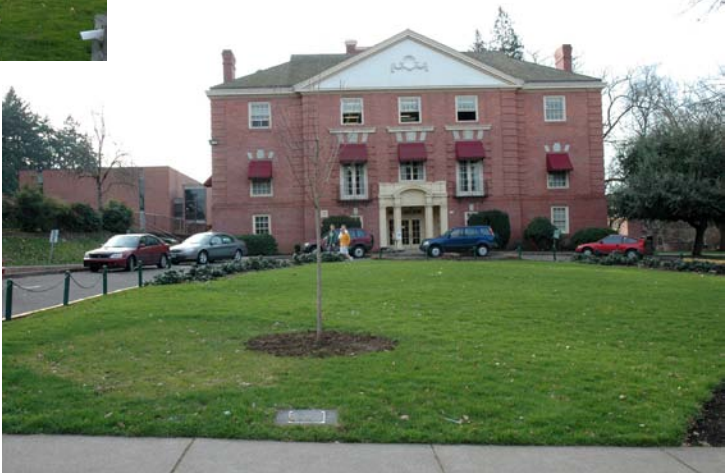
*View west from University Street towards Gerlinger Hall.*

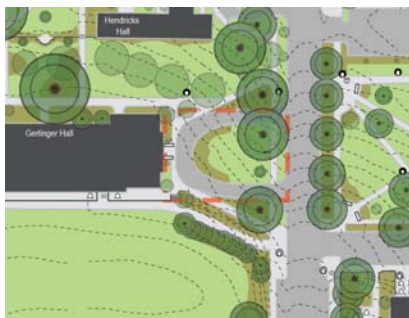
The Gerlinger Green is on a plane that slopes uniformly to the northeast (see diagram below). It has unobstructed southern exposure and high solar access.

The area's topography.

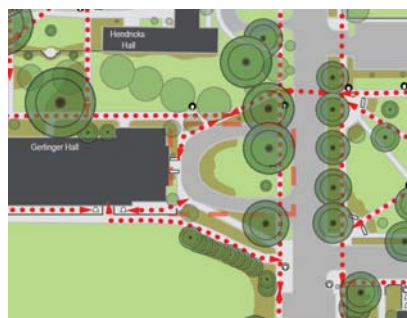
Diagram showing circulation paths.

The University Street sidewalk along the east edge of the Green is an important north-south connector on campus (see diagram, pg.6). The Knight Library Axis provides an east-west pedestrian corridor. There is no circulation across the interior of the turnaround area, effectively discouraged by a knee-high chain link fence along the western edge.
