LANDSCAPE RESOURCE SURVEY
 University of Oregon Campus Heritage Landscape Plan
 Eugene, Lane County, Oregon • Spring 2007

Emerald Axis (s)

Landscape Resource Survey
EMERALD AXIS

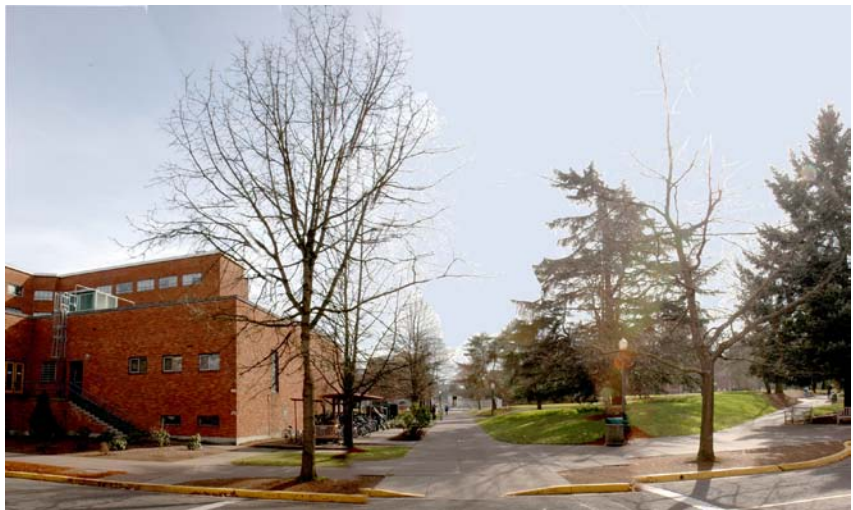
Panoramic view looking south with Carson Hall to the left.

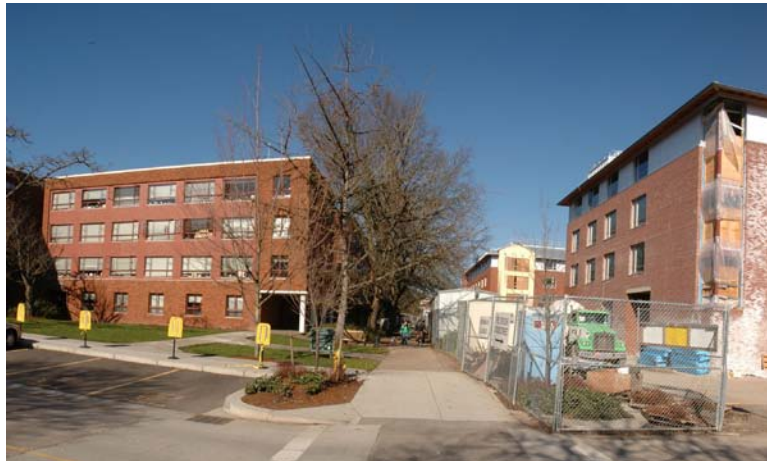
View north with the new Living Learning Center under construction at right.

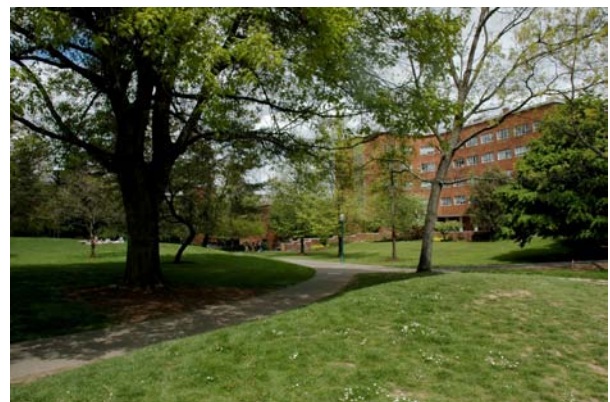
Looking southwest toward Earl Hall.
